# VEHICLE INSPECTION REPORT

**BL68OVF**

## Iveco Eurocargo 180-250

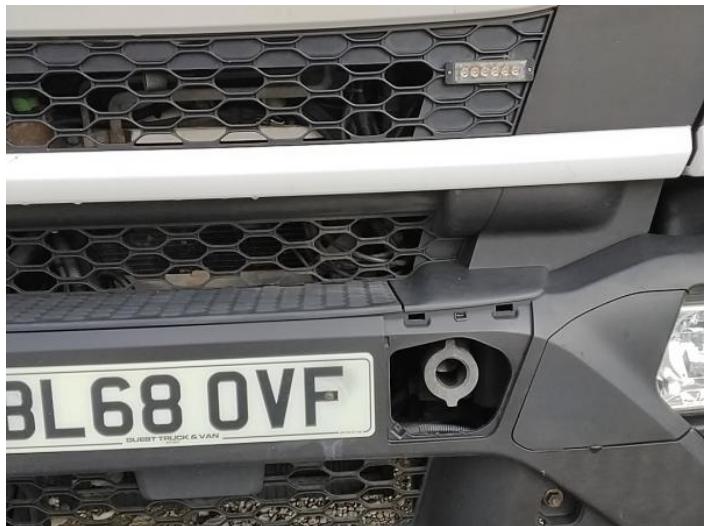
2: Front TowEye Cvr  
Missing  
Replace

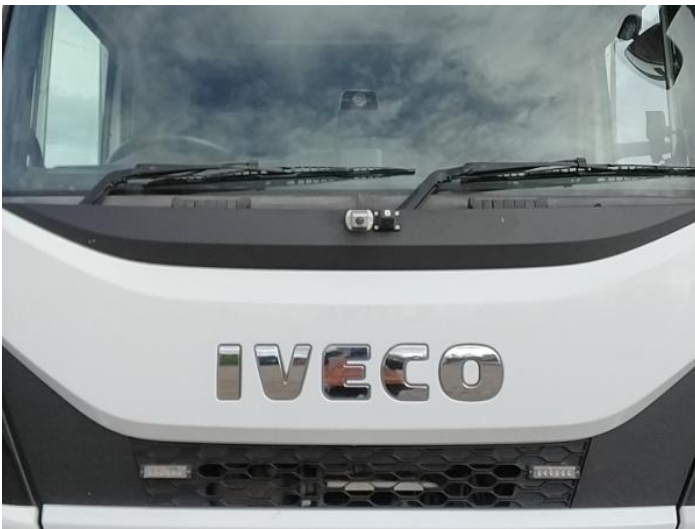
5: Bonnet  
Chipped  
Multiple Chips

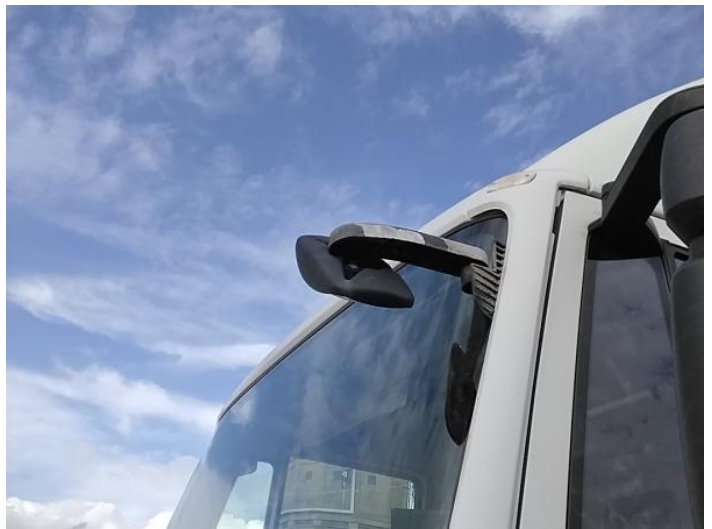
6: Door Mirror Assy nsf  
Broken  
Replace

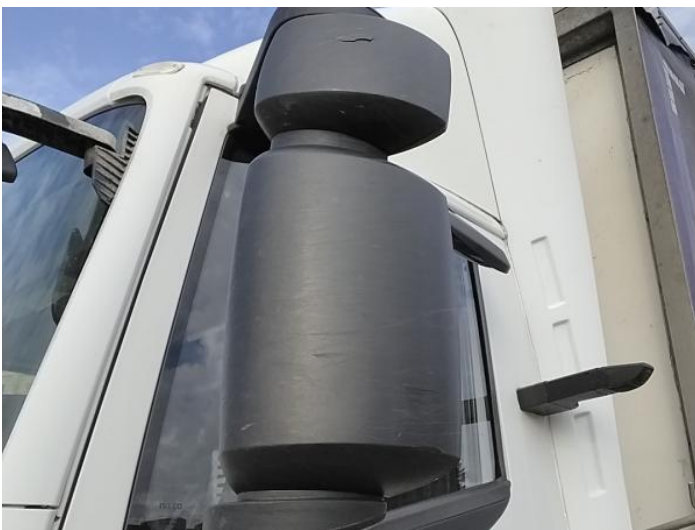
7: Door Mirror Assy nsf  
Broken  
Replace

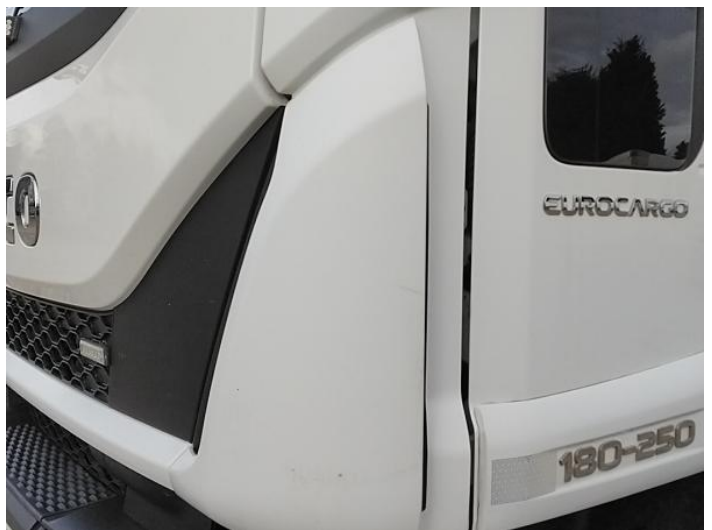
8: Wing nsf  
Scratched  
UpTo 25mm Not Thru Paint

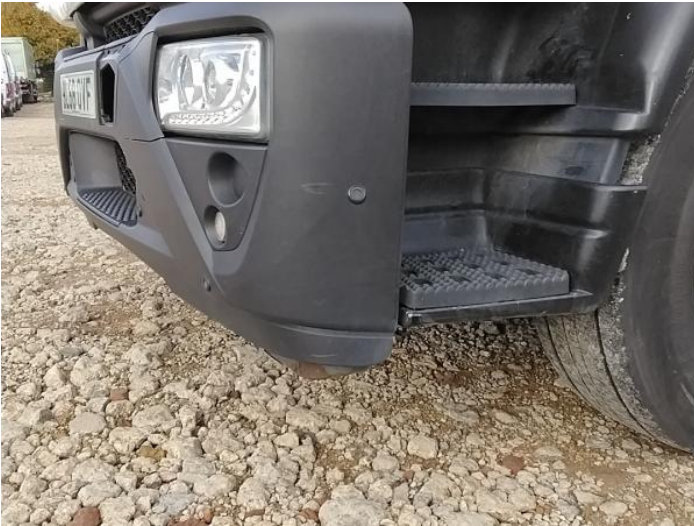
9: Bumper Front Moulding  
Scuffed (Unpainted)  
UpTo 100mm

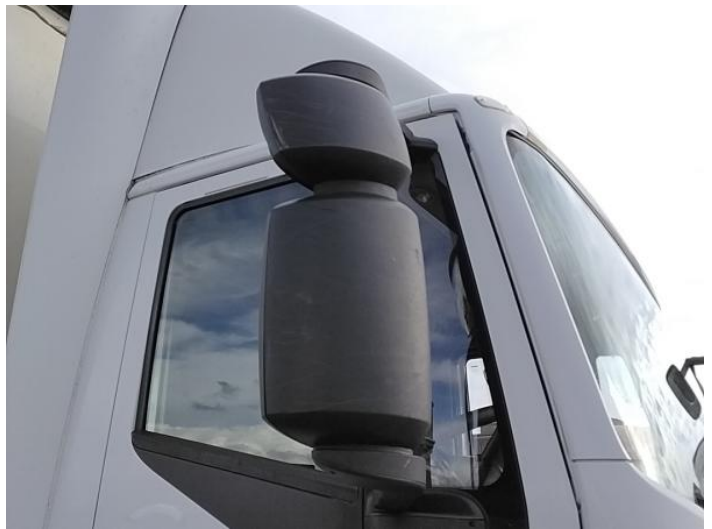
12: Door Mirror Assy osf  
Scuffed (Unpainted)  
UpTo 100mm

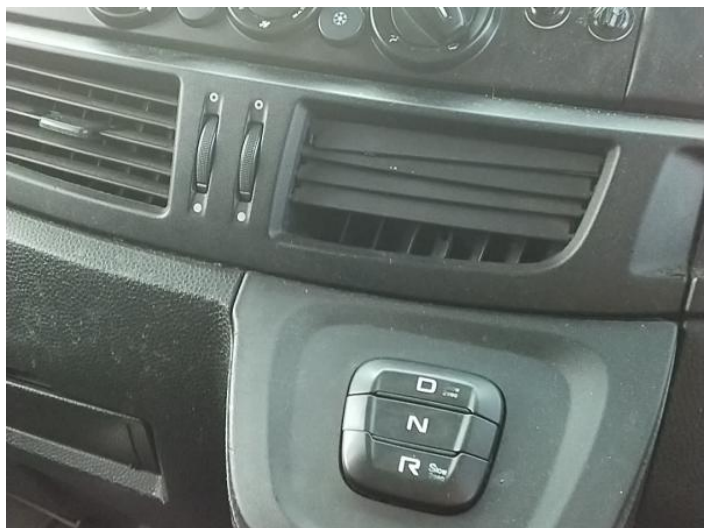
14: Air Vents osf  
Damaged  
Replace
