VEHICLE INSPECTION REPORT

AO67VUN

Land Rover Range Rover Sport 3.0 SDV6 306 HSE Dynamic

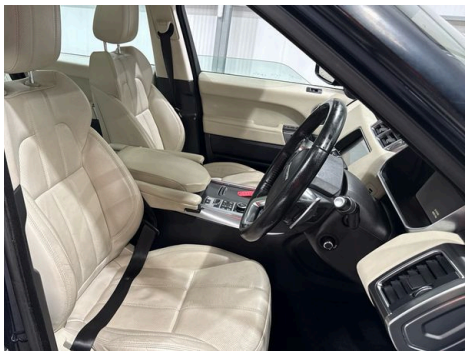
NO FRONT NUMBER PLATE, SMOKING KEYLESS IGNITION

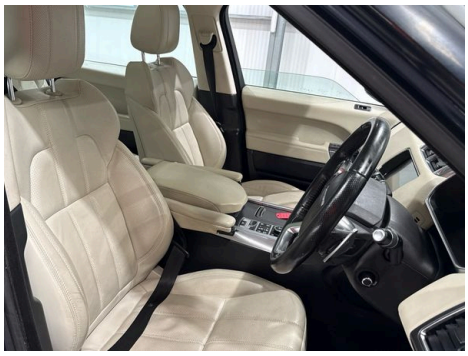
Ignition On
38miles
089827 miles

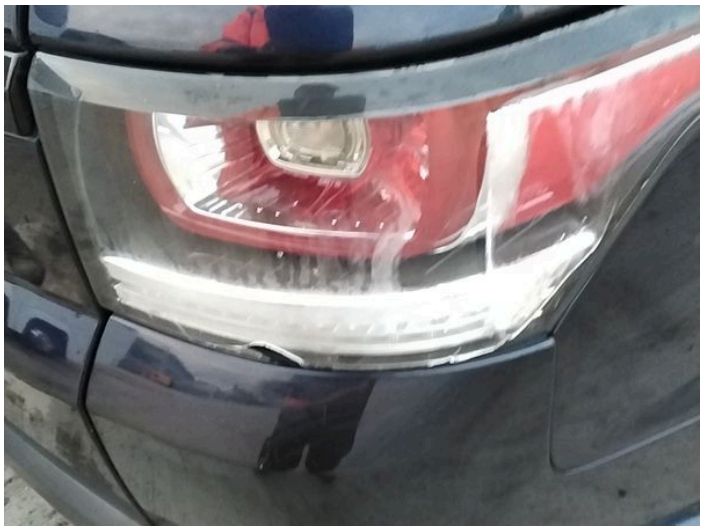
1: Wing osf
Scratched
Over 25mm Thru Paint

2: Bonnet
Chipped
Multiple Chips

3: Number Plate Front
Missing
Replace

4: Bumper Front Moulding
Scuffed (Unpainted)
UpTo 100mm

5: Bumper Front
Poor Previous Repair
Rippled UpTo 30%

6: Bumper Front
Scratched
Over 100mm Thru Paint

7: Door nsf
Scratched
Over 25mm Thru Paint

8: Door nsr
Scratched
Over 25mm Thru Paint

9: Door nsr
Chipped
Multiple Chips

10: Qtr Panel nsr
Scratched
Over 25mm Thru Paint

11: Boot Lid
Scratched
Over 25mm Thru Paint

12: Boot Lid
Scratched
Over 25mm Thru Paint

13: Lamp osr
Broken
Replace

14: Qtr Panel osr
Scratched
Over 25mm Thru Paint

15: Wheel osr
Scratched
Over 50mm

16: Door osr
Scratched
Over 25mm Thru Paint

17: Door osf
Chipped
Multiple Chips

18: Door osr
Dented
Over 30mm

19: Seat Base Cover osr
Soiled
Heavy
